Docket No. 217 – Development and Management Plan Inspection

Date: January 7, 2005

Location: Norwalk Substation Expansion

Location: Plumtree Substation Expansion , Bethel

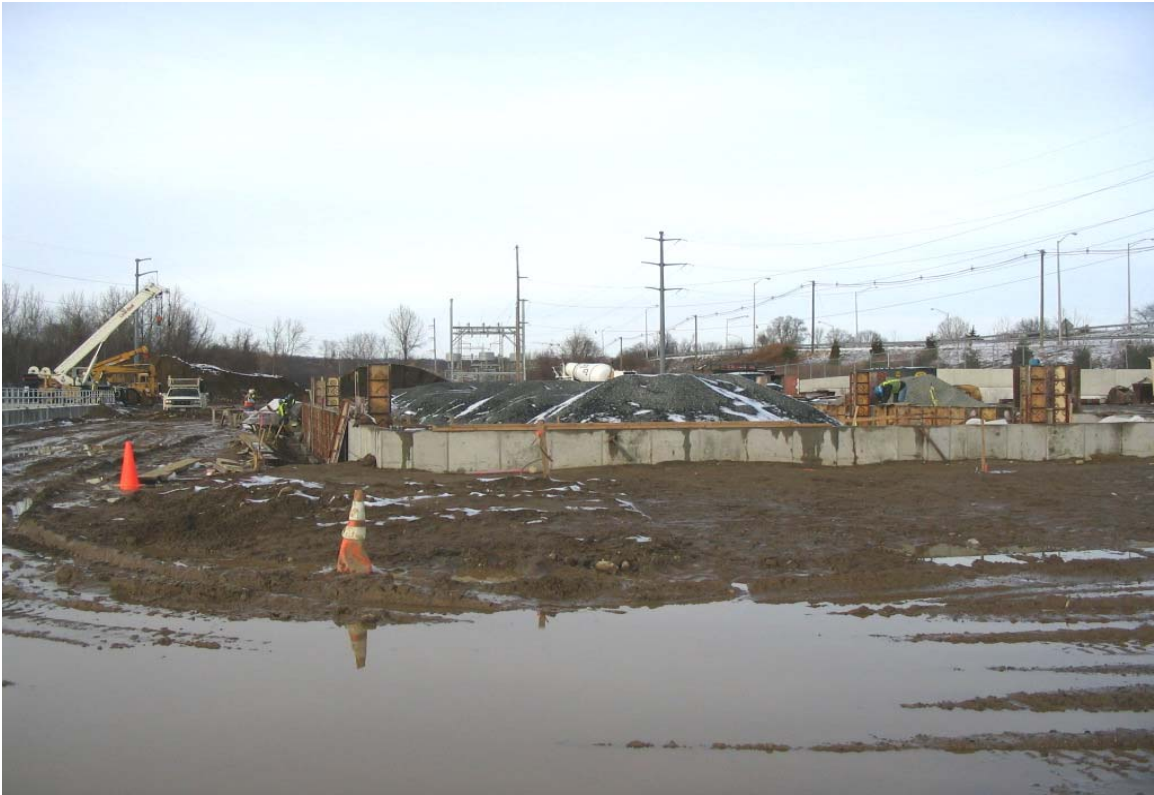
View of the forms and structures being constructed for the GIS building looking north. The overall site was muddy following a few inches of snow. 1/07/05

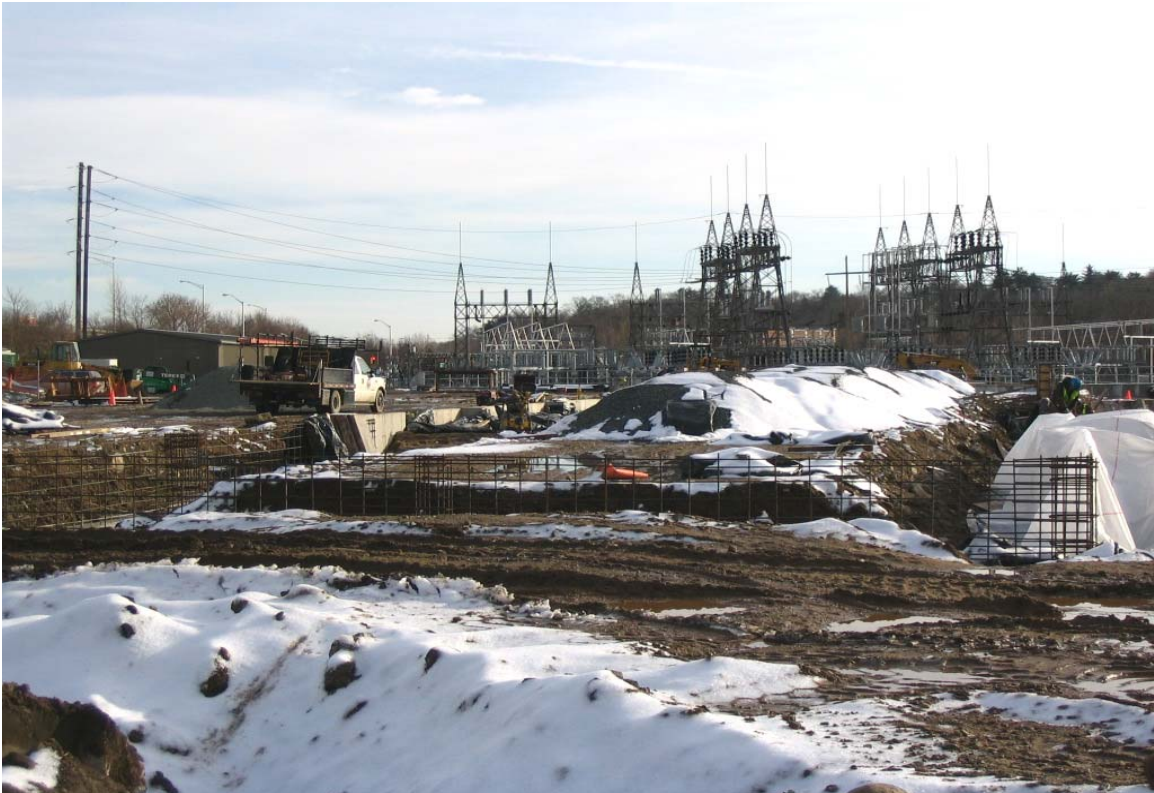
View of the forms and structures being constructed for the GIS building looking south. 1/07/05

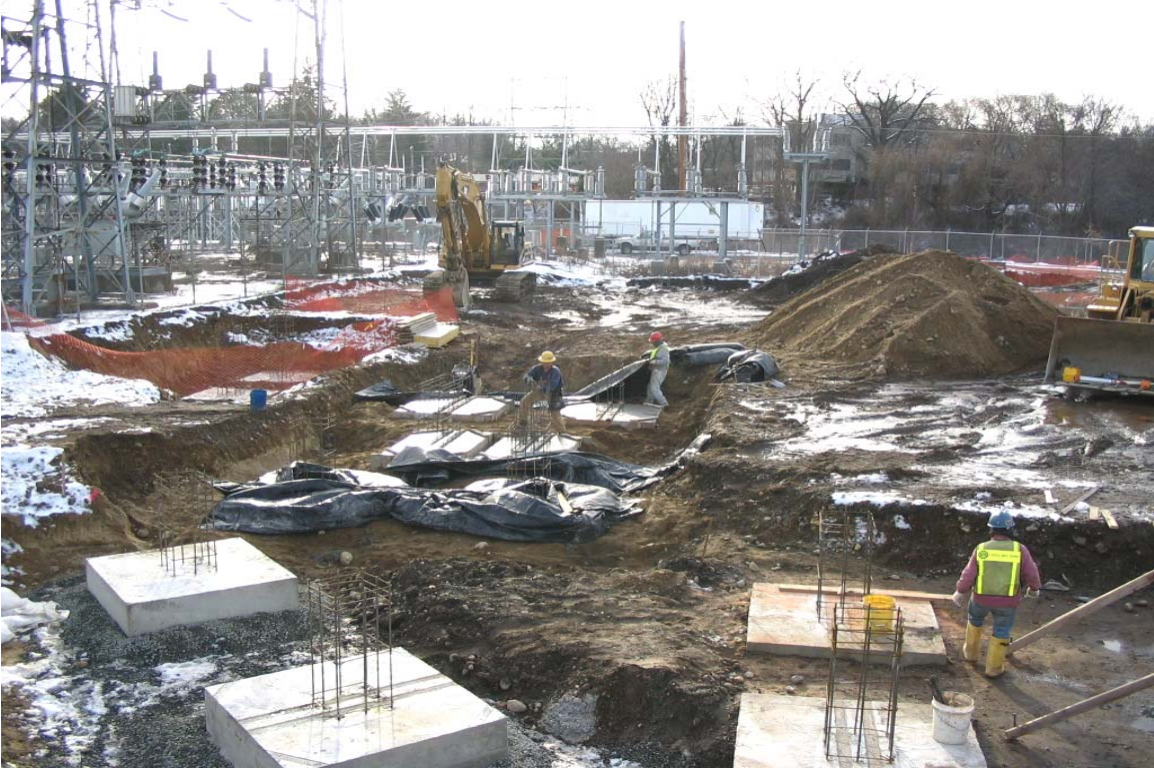
Excavation continues to the south of wall #3 and footings are being poured for structures for the continued expansion of the existing yard. 1/07/05

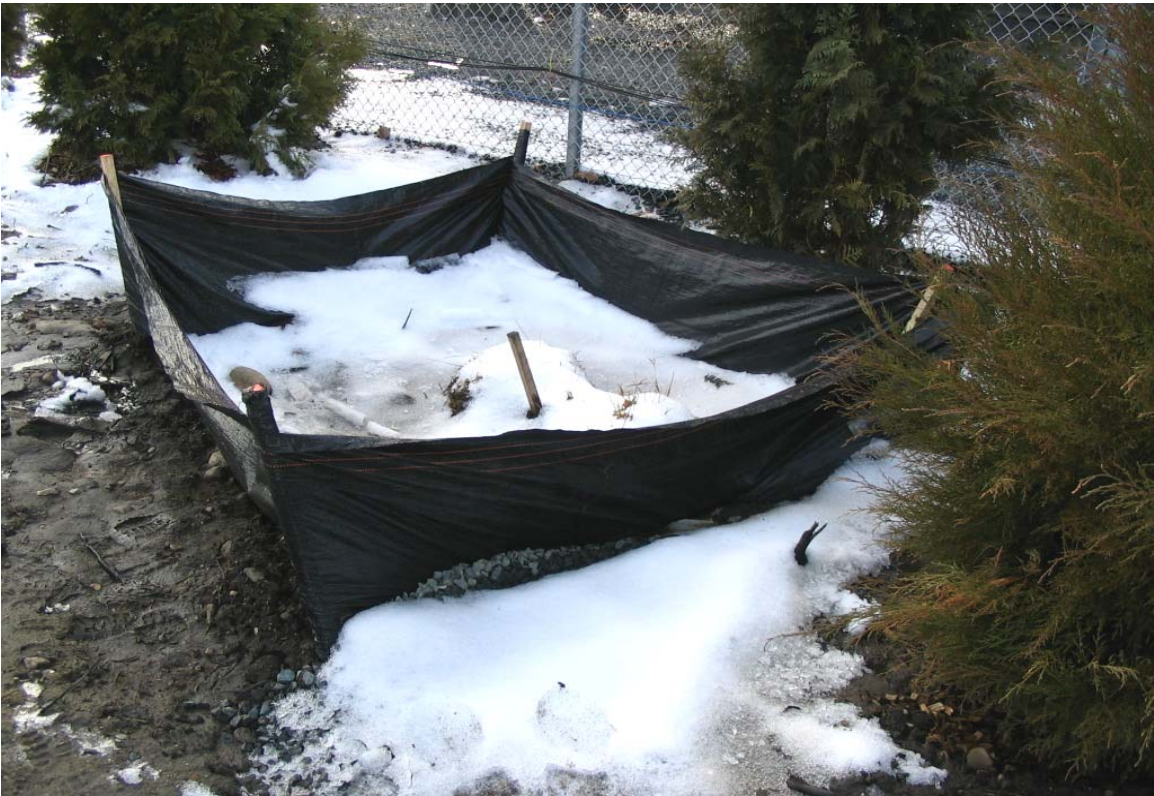
- The haybale is still placed at the flared inlet near the Rt 7 ramp, and the silt fence was repaired and reinforced with crushed stone. 1/07/05	- Continue to monitor until stabilized as the surrounding area is still bare soil. Until vegetative cover establishes, the potential for sedimentation in this area remains 1/07/05

The haybale remains at the inlet near the Route 7 ramp. The silt fence was repaired and reinforced with crushed stone. Continue to monitor the surrounding area until stabilized. 1/07/05

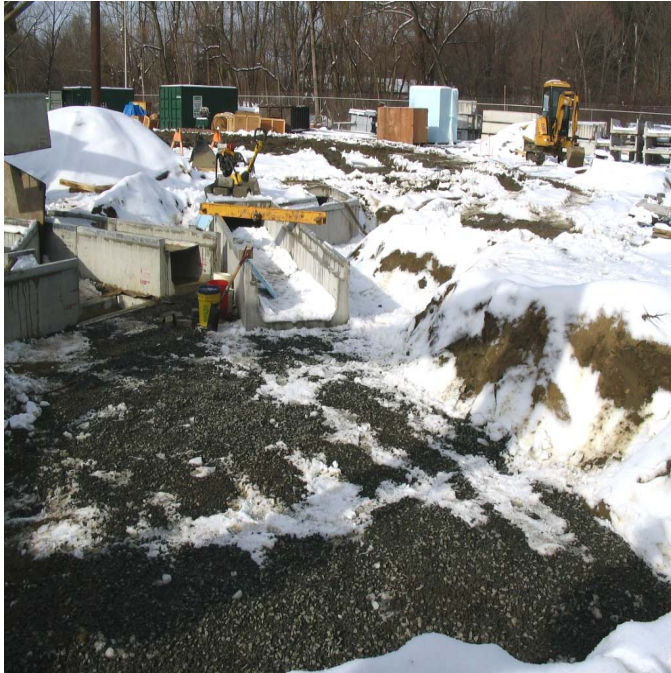
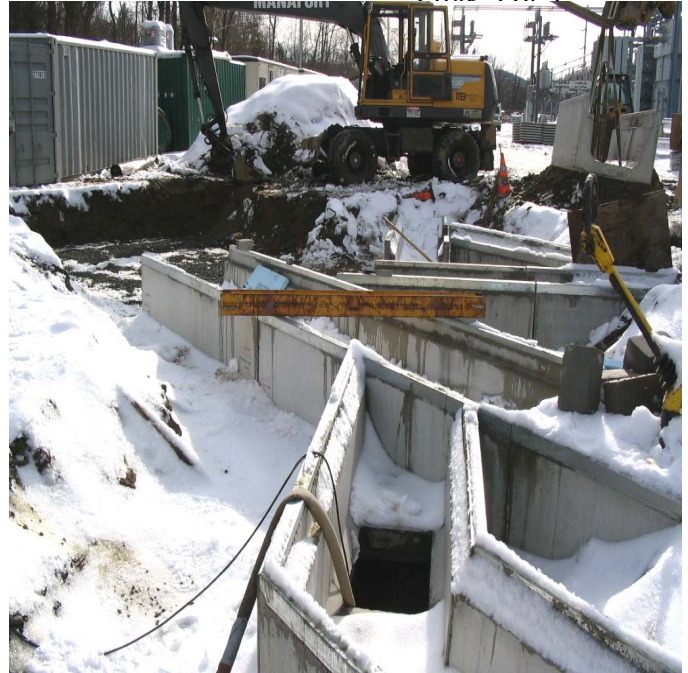
Plumtree Substation: View of the excavation and forms of the cable trench closer to the perimeter fence. The stockpile is contained within the site and covered. 1/07/05

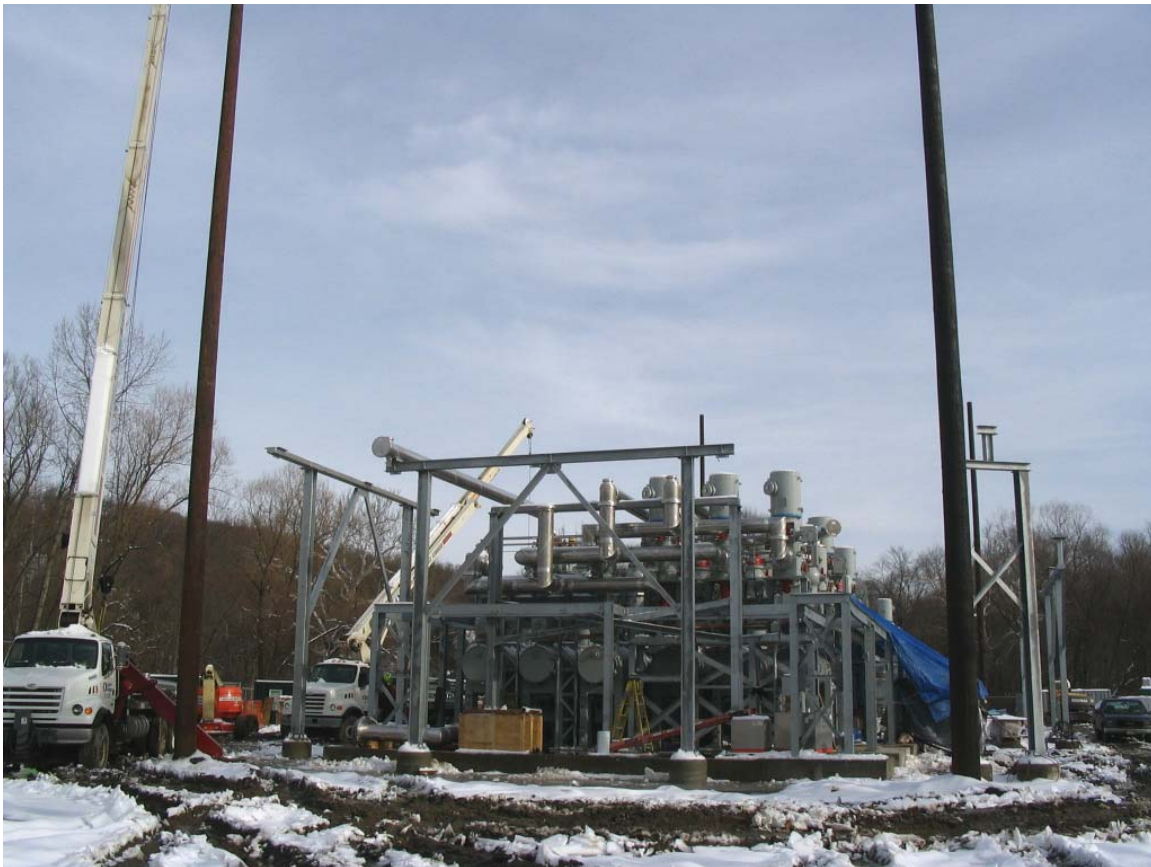
Poles have been set at the corners of the concrete slab and equipment construction. The site is very muddy at this time but contained. 1/07/05
